Increased accessibility reduces the cost

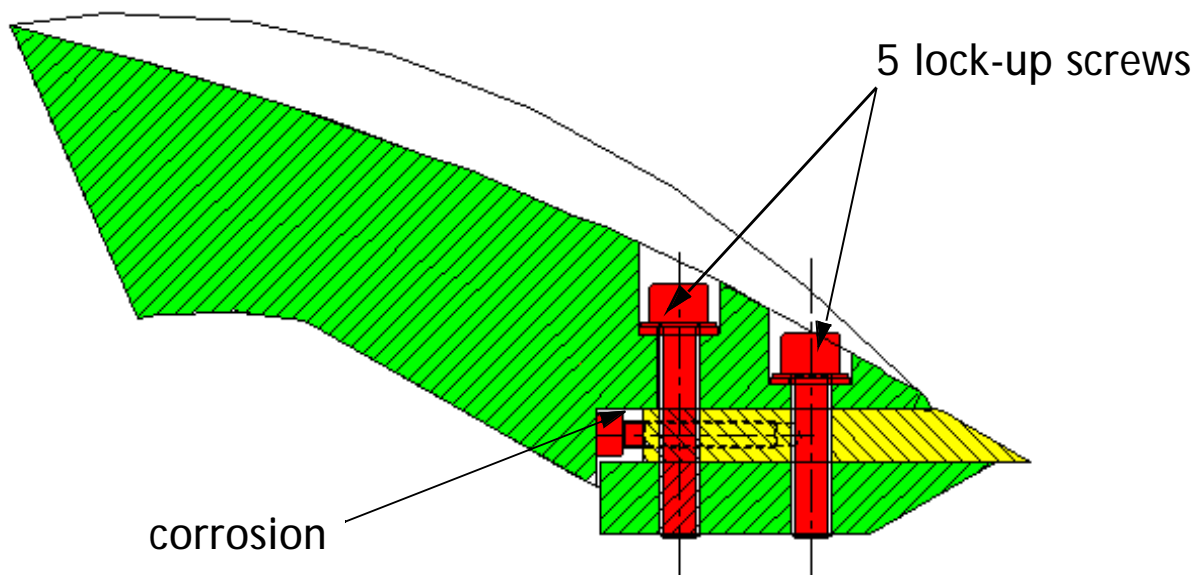
It has been known by inspections on the chipper heads that there has formed rust on the seats for the chipper knives.

The corrosion makes a heightening so that a loose between knife and the contact surface can be the result when changing knives that are different much grinded or changing to new knives. This can lead to defects on the chipper heads which can result in broken screws and the knives get loose.

To obstruct this it is important that the seats for the knives become cleaned at regular intervals, suitable as preventive service once a month. After cleaning and change of knives, the contact surface should be prepared with thin-boided slushing oil e.g. 5-56. The lockup screws and the washers should also be changed every 6.th month at 1-shift drive, to guarantee the strength.

With this discovery, we have introduced 2 extra lock-up screws on the new chipper heads, to increase the security. The screws are situated behind the existing ones, to give a more stabil lock-up of the knives. To additionally secure a good lock-up of the knives it is very important not to grind more than 25 mm of the knives, since it increases the risk to get damage on the chipper heads and knives get loose.
